Case 398 : Narrative

Case Vehicle (A): 2000 Ford	Vehicle (B): 2002 Ford
Type: Taurus SE, 4-door sedan	Type: Mustang GT, 2-door coupe
Driver: 19-year-old male	Driver: 44-year-old male
CDC: 12-FREW-3, 00-TDDO-3	CDC: 12-FREE-6

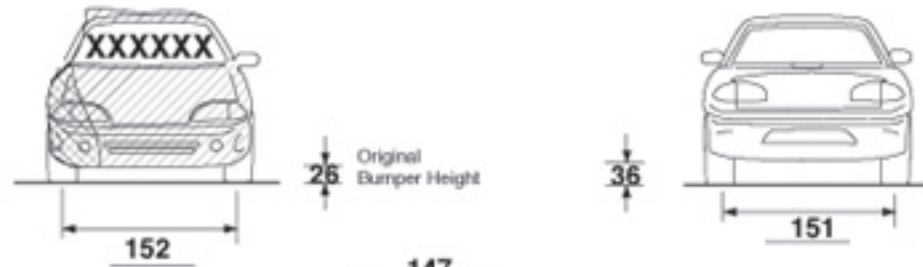
MEASUREMENTS IN CENTIMETERS

Trim panel knocked off

Max. crush to right-front bumper corner

Left-front tire flat and it's movement restricted
